SERVICE BULLETIN

TITLE: FUSELAGE - WING FORWARD SPAR CARRY-THRU STRUCTURE INSPECTION AND/OR REINFORCEMENT

AP-1260 M

SB 53-2269, REV. 2

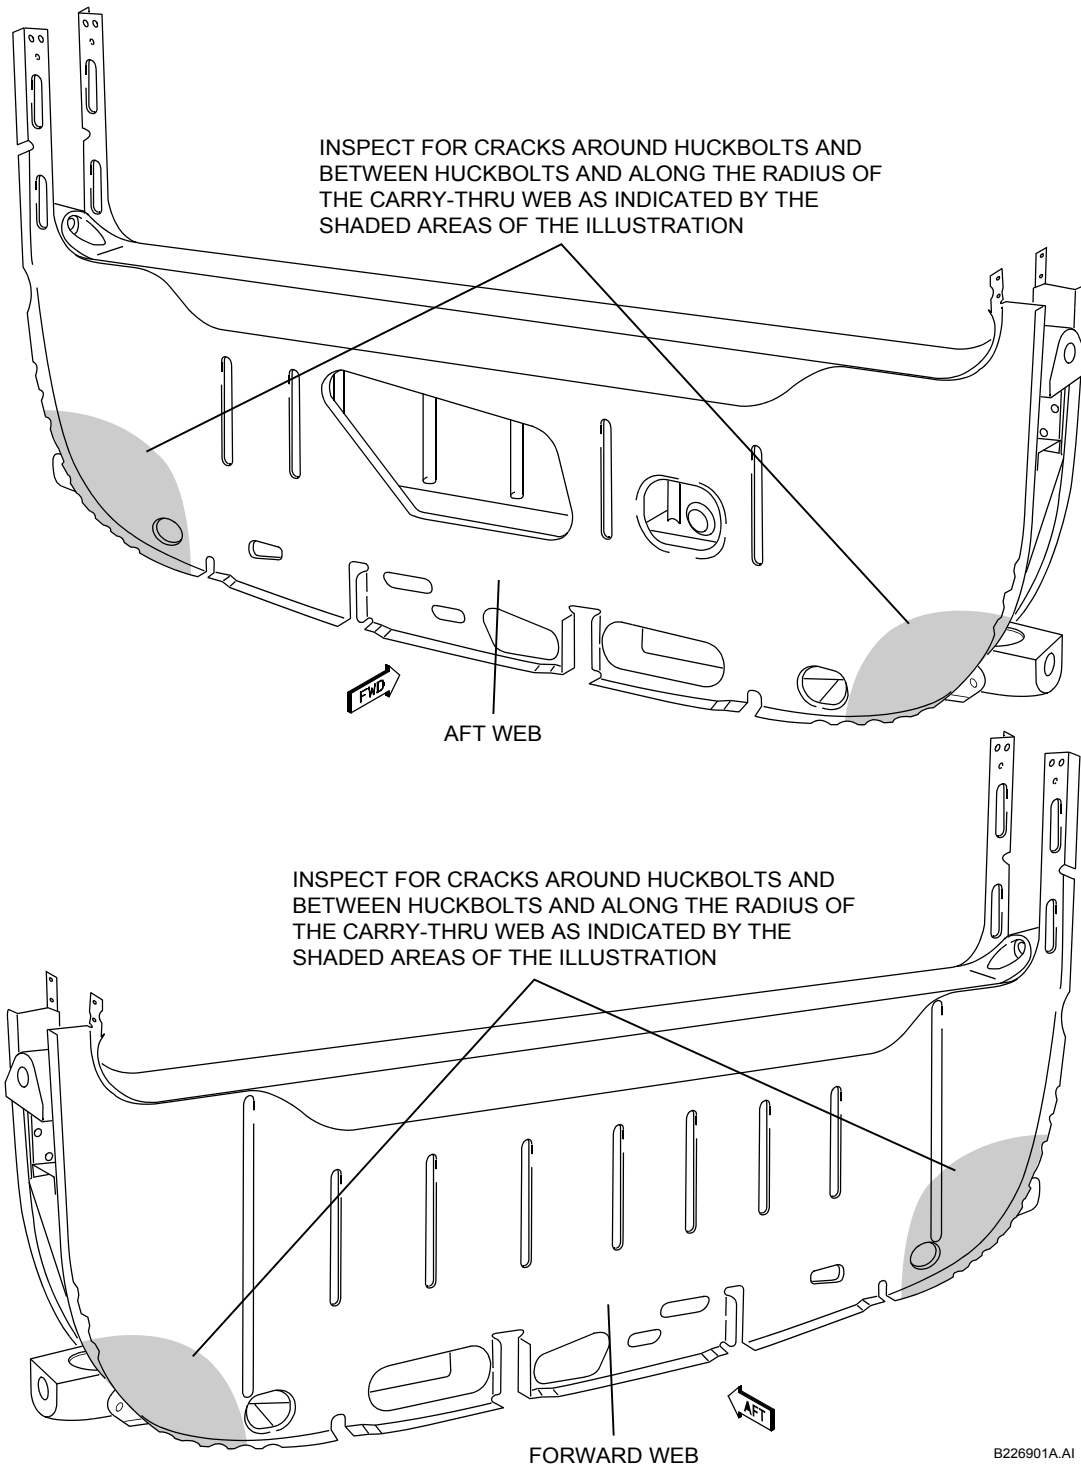
This Service Bulletin is being issued to provide inspection and repair information relating to forward wing spar carry-thru structure forward and aft frames. Reports of frame (web) cracking have been received on in-service airplanes. If these cracks are detected at any time, the repairs described in this Service Bulletin should be applied.

- (2) Remove the pilot's and copilot's seats and the carry-thru cover to obtain access to the front spar carry-thru structure.
- (3) Thoroughly clean the forward and aft frames (webs) of the front spar carry-thru structure in the shaded areas shown in Figure 1.
- (4) Perform a visual inspection of the area cleaned in step 3 for evidence of cracks.
- (5) Perform a dye penetrant inspection using visible dyes, of the area cleaned in step 3 for evidence of cracks.

Cracks found in the shaded areas of Figure 1 that have not been modified by a doubler must be repaired as indicated in this Service Bulletin on an individual basis.

The extent of repair is limited to cracking in the radius of the web flange and cracks in the web flat areas at the fasteners of the lower front spar cap.

Inspection for Cracks in the Wing Forward Spar Carry-Thru Structure Forward and Aft Frames

- (a) For cracks in the bend radius:
 - (i) A crack up to 4.0 inches in length shall be stop drilled at the ends using a #30 drill bit. The area is to be repaired per the applicable P/N 58-4008 Kit(s) within the next 100 flight hours, 12 calendar months or the next scheduled inspection whichever occurs first.

- (ii) A crack exceeding 4.0 inches in length shall be repaired PRIOR TO FURTHER FLIGHT per the applicable P/N 58-4008 Kit(s).

- (b) For cracks in the web face, in the area of the huckbolt fasteners:
 - (i) A crack emanating from one fastener in two directions is considered to be one crack. **Do not stop drill, due to the possibility of damaging structure behind web face.**
 - (ii) Any crack shall be repaired per the applicable P/N 58-4008 Kit(s), within the next 25 flight hours, 12 calendar months or the next scheduled inspection whichever occurs first.
 - (iii) A crack passing through two fasteners and extending beyond for more than 0.5 inch on either end shall be repaired PRIOR TO FURTHER FLIGHT, per the applicable P/N 58-4008 Kit(s).
 - (iv) A crack passing through two fasteners and extending beyond for less than 0.5 inch on both ends shall be repaired per the applicable P/N 58-4008 Kit(s), within the next 25 flight hours, 12 calendar months or the next scheduled inspection whichever occurs first.

- (c) If cracks are found in both the forward and aft frames on the same side of the airplane, in either the web face and/or the bend radius, and any of the cracks are more than 1.0 inch long, a repair shall be made PRIOR TO FURTHER FLIGHT.

- (d) If cracks are found in both the forward and aft frames on the same side of the airplane, in either the web face and/or the bend radius, and all of the cracks are less than 1.0 inch long, a repair shall be made per the applicable P/N 58-4008 Kit(s) within the next 25 flight hours, 12 calendar months or the next scheduled inspection whichever occurs first.
