SERVICE BULLETIN

Beech

TITLE: FUSELAGE - WING FORWARD SPAR CARRY-THRU STRUCTURE INSPECTION AND/OR REINFORCEMENT

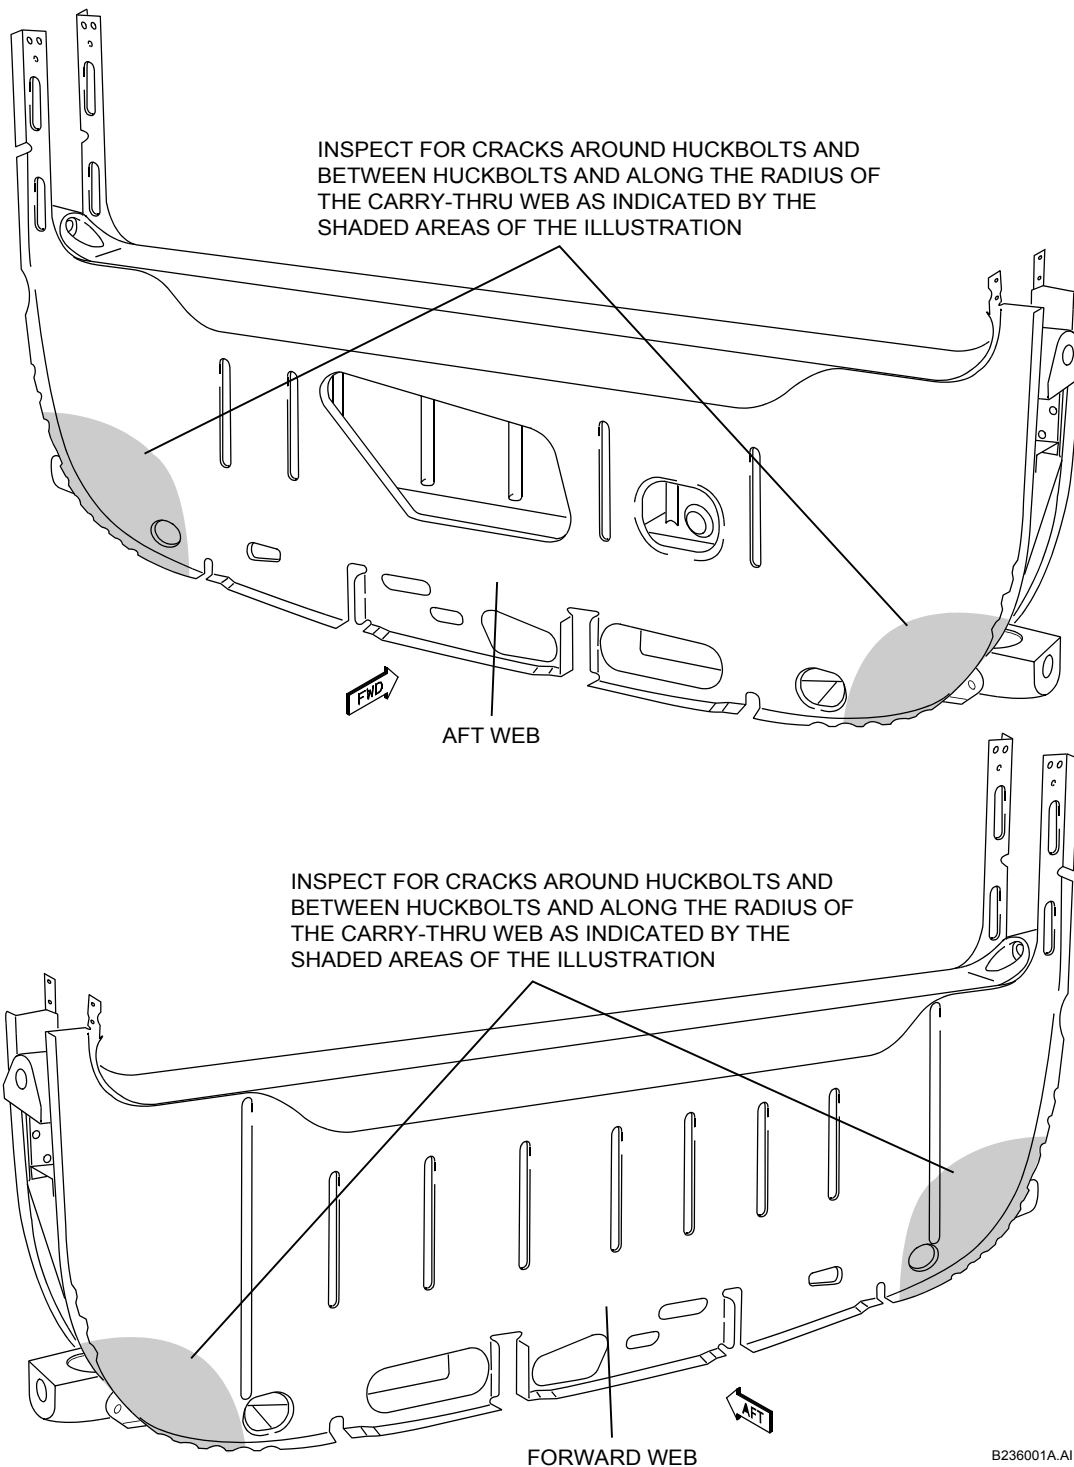
This Service Bulletin is being issued to provide inspection and repair information relating to forward wing spar carry-thru structure forward and aft frames. Reports of frame (web) cracking have been received on in-service airplanes. If these cracks are detected at any time, the repairs described in this Service Bulletin should be applied.

Cracks found in the shaded areas of Figure 1 that have not been modified by a doubler must be repaired as indicated in this Service Bulletin on an individual basis.

The extent of repair is limited to cracking in the radius of the web flange and cracks in the web flat areas at the fasteners of the lower front spar cap.

Inspection for Cracks in the Wing Forward Spar Carry-Thru Structure Forward and Aft Frames

- (i) A crack up to 4.0 inches in length shall be stop drilled at the ends using a #30 drill bit. The area is to be repaired per the applicable P/N 36-4004 Kit(s) within the next 100 flight hours, 12 calendar months or the next scheduled inspection whichever occurs first.
- (ii) A crack exceeding 4.0 inches in length shall be repaired PRIOR TO FURTHER FLIGHT per the applicable P/N 36-4004 Kit(s).

- (ii) Any crack shall be repaired per the applicable P/N 36-4004 Kit(s), within the next 25 flight hours, 12 calendar months or the next scheduled inspection whichever occurs first.

- (iii) A crack passing through two fasteners and extending beyond for more than 0.5 inch on either end shall be repaired PRIOR TO FURTHER FLIGHT, per the applicable P/N 36-4004 Kit(s).

- (iv) A crack passing through two fasteners and extending beyond for less than 0.5 inch on both ends shall be repaired per the applicable P/N 36-4004 Kit(s), within the next 25 flight hours, 12 calendar months or the next scheduled inspection whichever occurs first.
